**AL IQITADAR SCHOOL**  
**UNDER THE COMMANDER'S EMERGENCY RESPONSE PROGRAM**  
**ANBAR PROVINCE, IRAQ**

**SUSTAINMENT ASSESSMENT**

**SIGIR PA-08-141**  
**JANUARY 26, 2009**

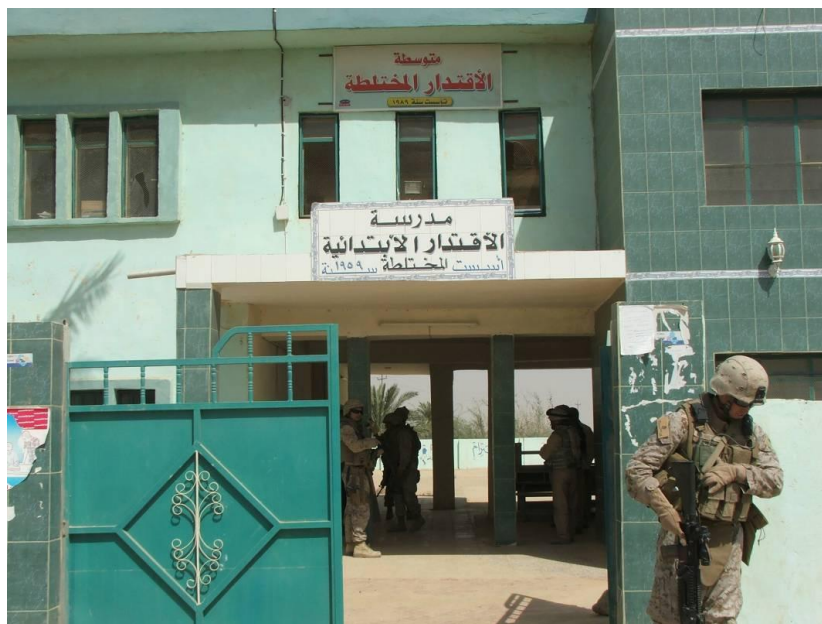
Site Photo 5. Al Iqtidar School on 21 September 2008

On 21 September 2008, the SIGIR assessment team performed an on-site assessment of the Al Iqitadar School project (Site Photo 5). SIGIR was escorted to the site by the local U.S. Marine unit and accompanied by the school's headmaster. At the time of the site visit, the school year had not started.
